DEPARTMENT OF TRANSPORTATION

Contract #: 04-0120F4Cty: SF/ALA Rte: 80 PM: 13.2/13.9File #: 69.28**WELDING INSPECTION REPORT****Resident Engineer:**Pursell, Gary**Address:** 333 Burma Road**City:** Oakland, CA 94607**Report No:** WIR-012287**Date Inspected:** 27-Feb-2010**Project Name:** SAS Superstructure**OSM Arrival Time:** 700**Prime Contractor:** American Bridge/Fluor Enterprises, a JV**OSM Departure Time:** 1900**Contractor:** Zhenhua Port Machinery Company, Ltd (ZPMC), Changxing Island **Location:** Shanghai, China

Orthotropic Box Girder (OBG) Trial Assembly Areas

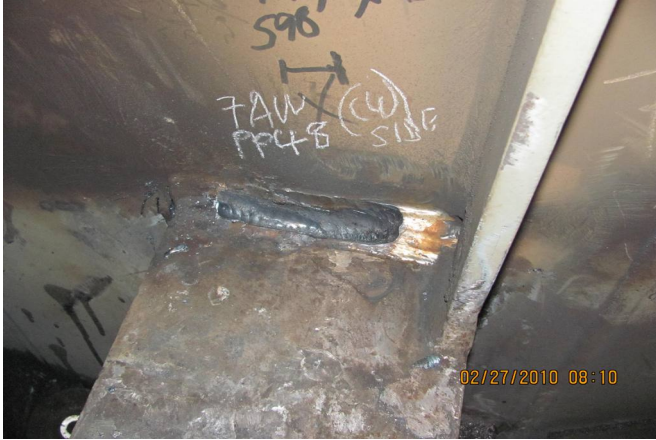
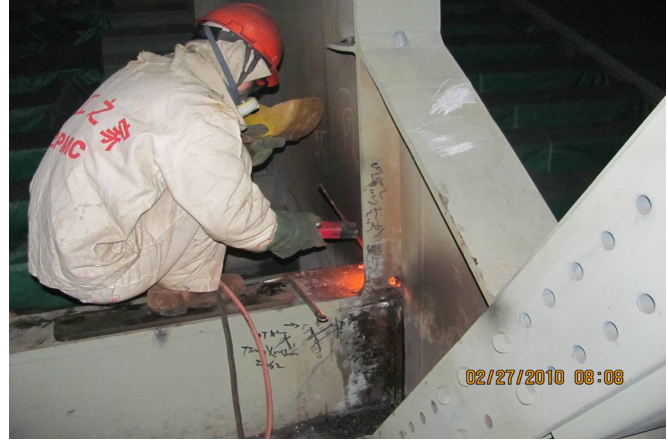
This Quality Assurance (QA) Inspector observed ZPMC qualified welder 048659 performing repair welding by Shielded Metal Arc Welding process (SMAW) for weld Seg 033B-001 located on PCMK Longitudinal Diaphragm Flange to Floor connecting weld for OBG Segment 7AW (Counter Weight Side). ZPMC CWI Mr. Wu Chi Shen monitoring this welding. The welding variables recorded by QC appeared to comply with the WPS-345-SMAW-1G (1F)-Repair. The welding was been performed against Welding Repair Report (WRR) B-WR10697 Rev. 0. Please refer pictures attached below for more comprehensive details.
